ERDC/GSL TR-03-7

Enhanced Coastal Trafficability: Road Construction Over Sandy Soils

July 2003

Final report

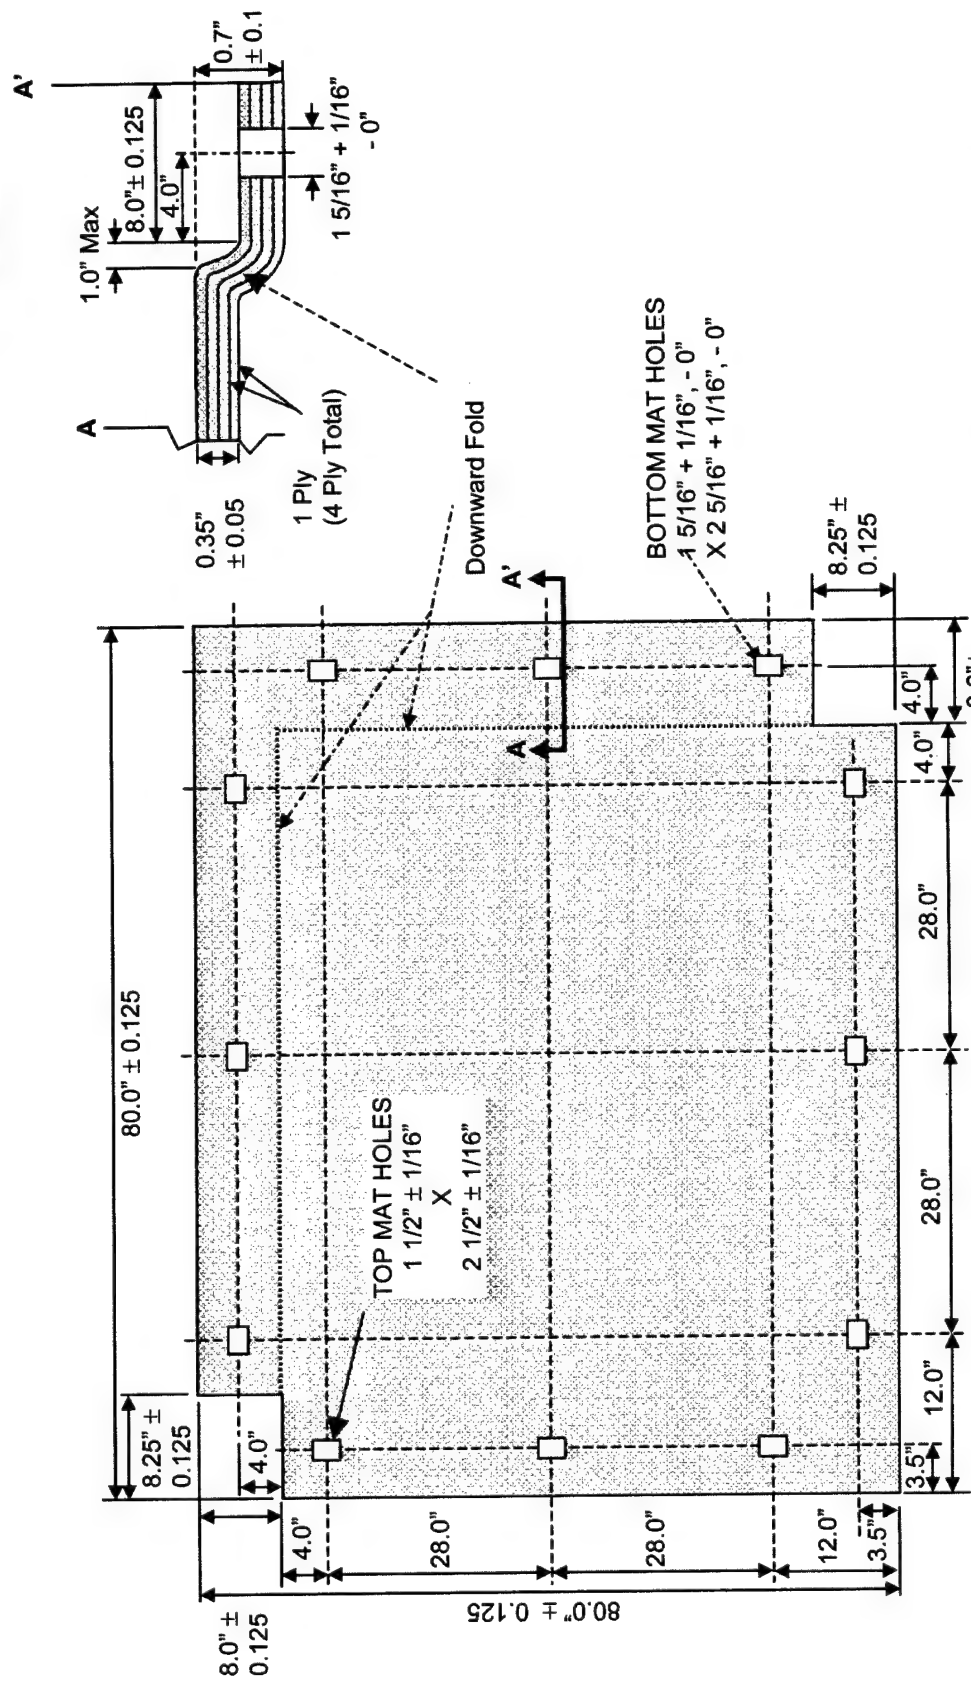
No. Plys	Thickness $\pm 0.05''$	Weight lbs	Weight lb/ft ²
4	0.35''	115	2.93

Figure 1. MP mat dimensions

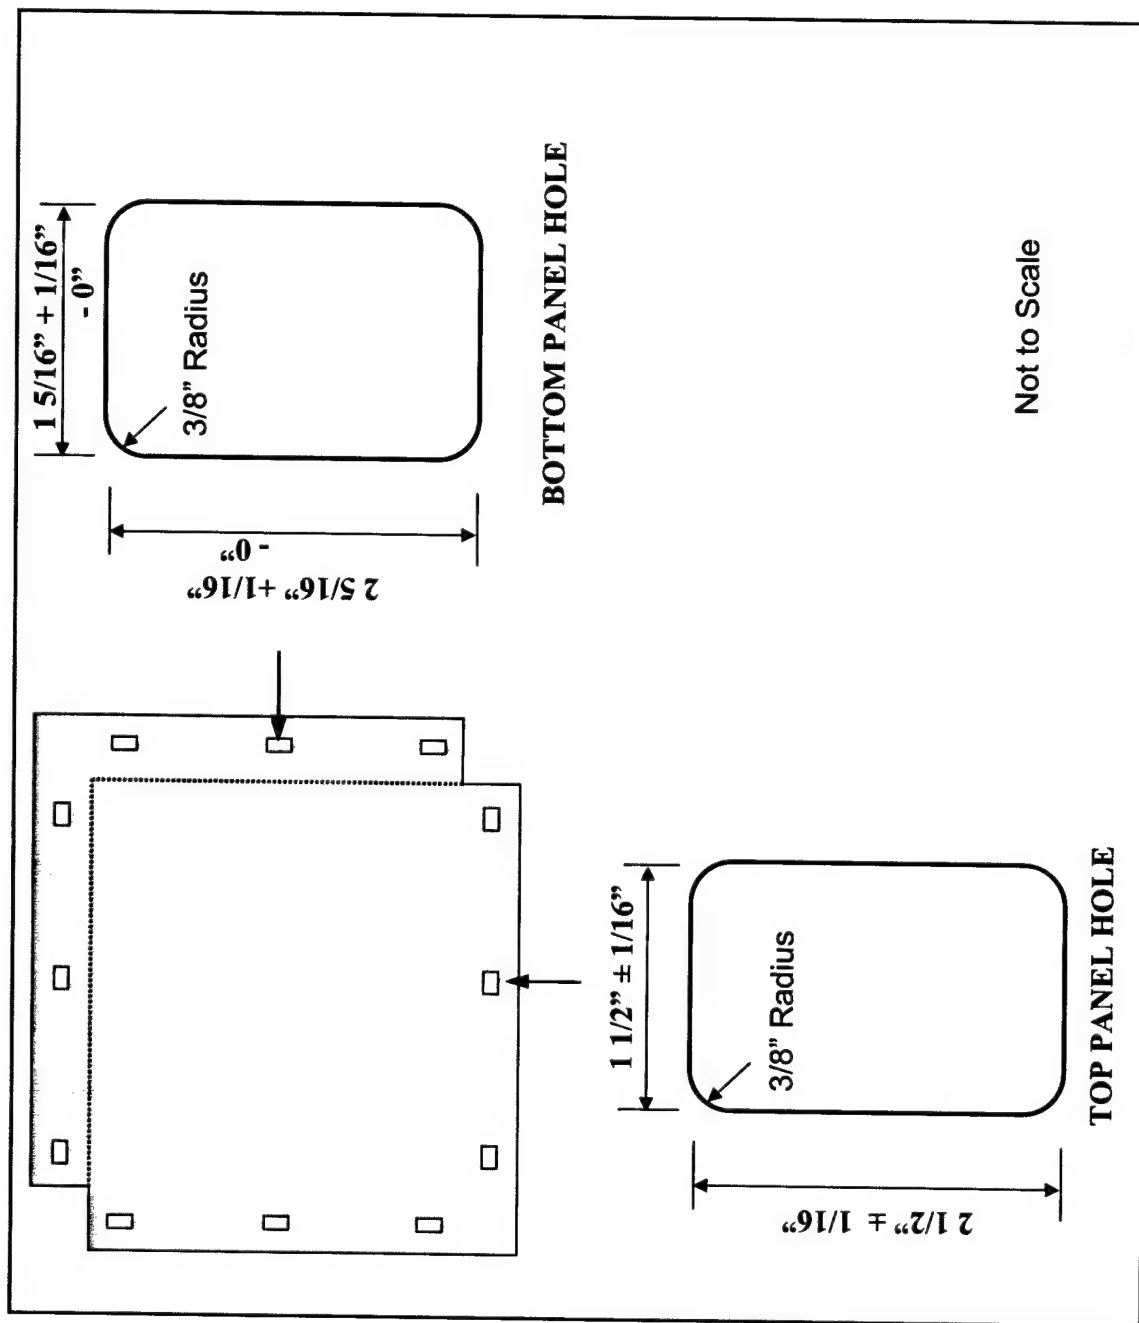
Figure 2. MP mat rectangular hole dimensions

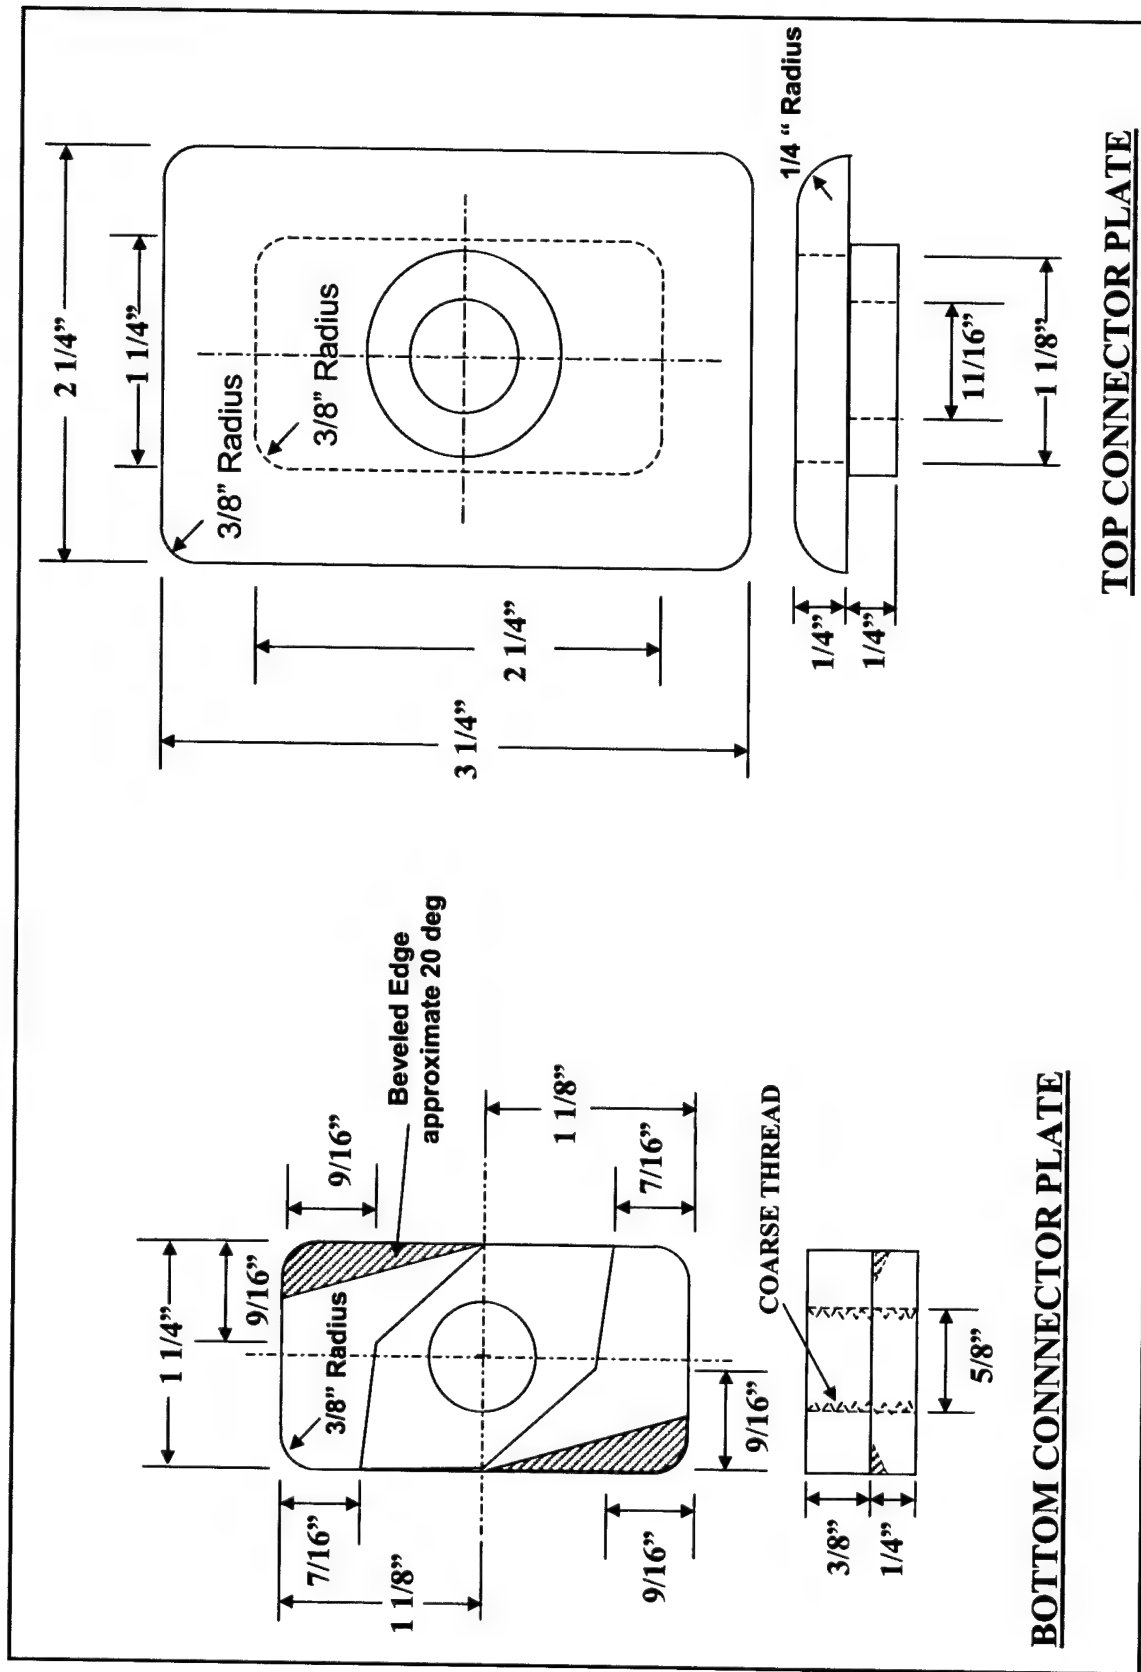
Figure 4. Aluminum drop-in pin connector plate dimensions

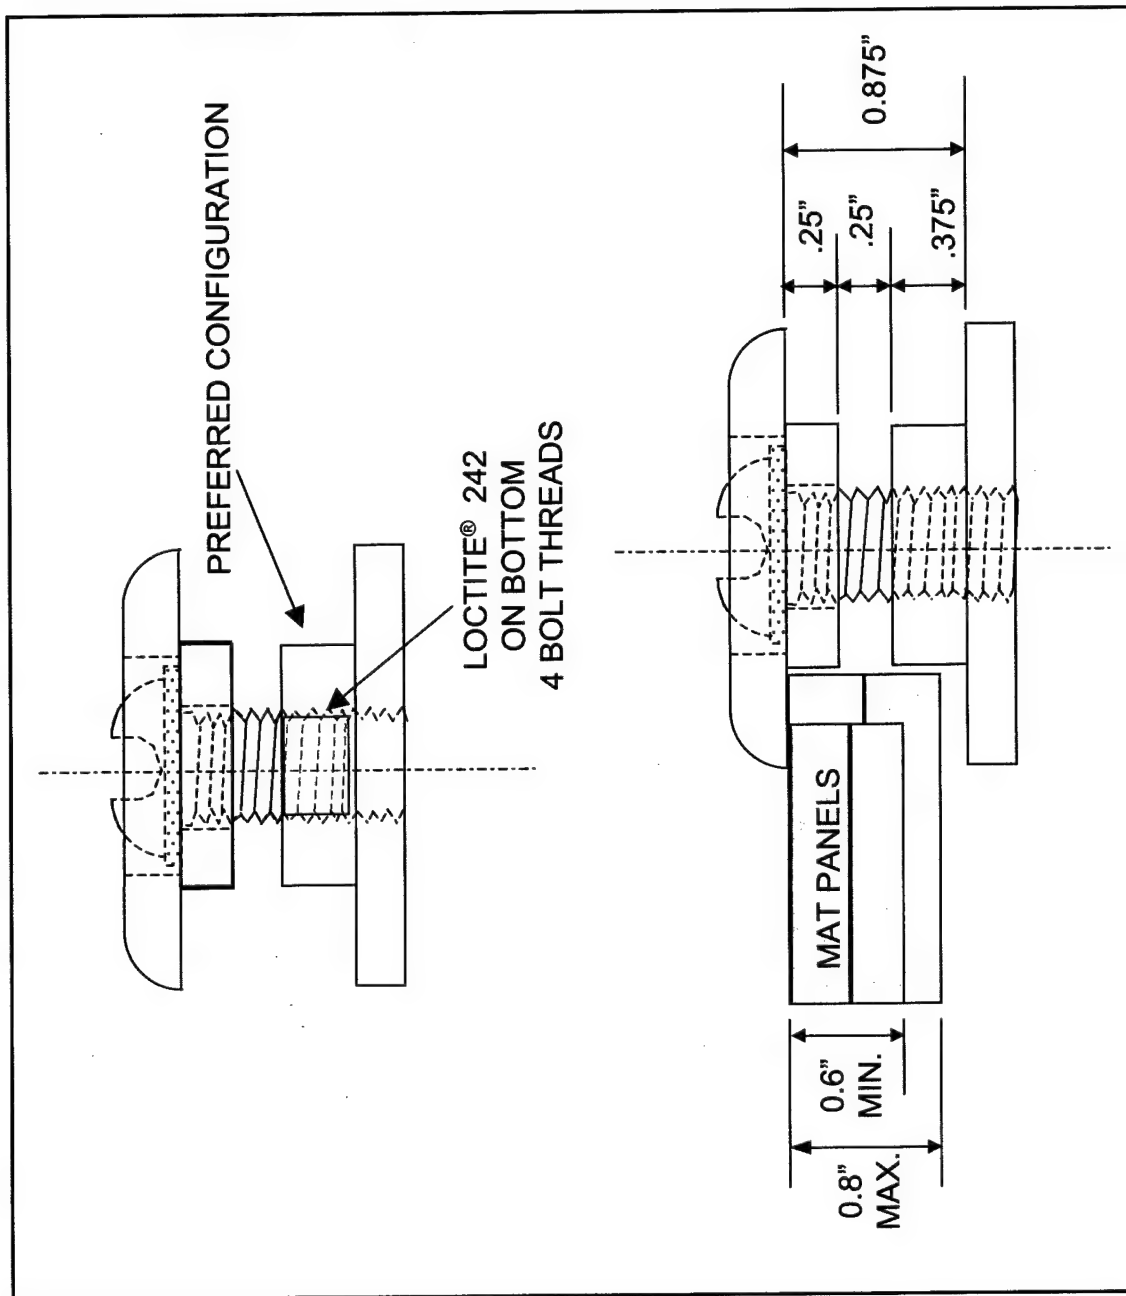
Figure 5. Aluminum drop-in pin connector configurations for locking bottom connector plate to cap screw and tolerance ranges

A cam on the bottom pin plate stops rotation of the bottom plate at 90 degrees to the holes in the mat panels. The rotated bottom plate below the bottom mat panel then allows the pin connector to be tightened and lock the two mat panels together. During tightening, the thread locker breaks under medium torque to allow the cap screw to be fully tightened. During disassembly, the thread locker again breaks under moderate torque allowing the cap screw to be loosened. As the pin is loosened, the thread locker retains sufficient locking strength to force the bottom plate to rotate back 90 degrees. After rotating 90 degrees, the cam on the bottom pin plate stops the rotation to align the bottom plate with holes in the mat panels. The aluminum drop-in pin connectors are then removed.

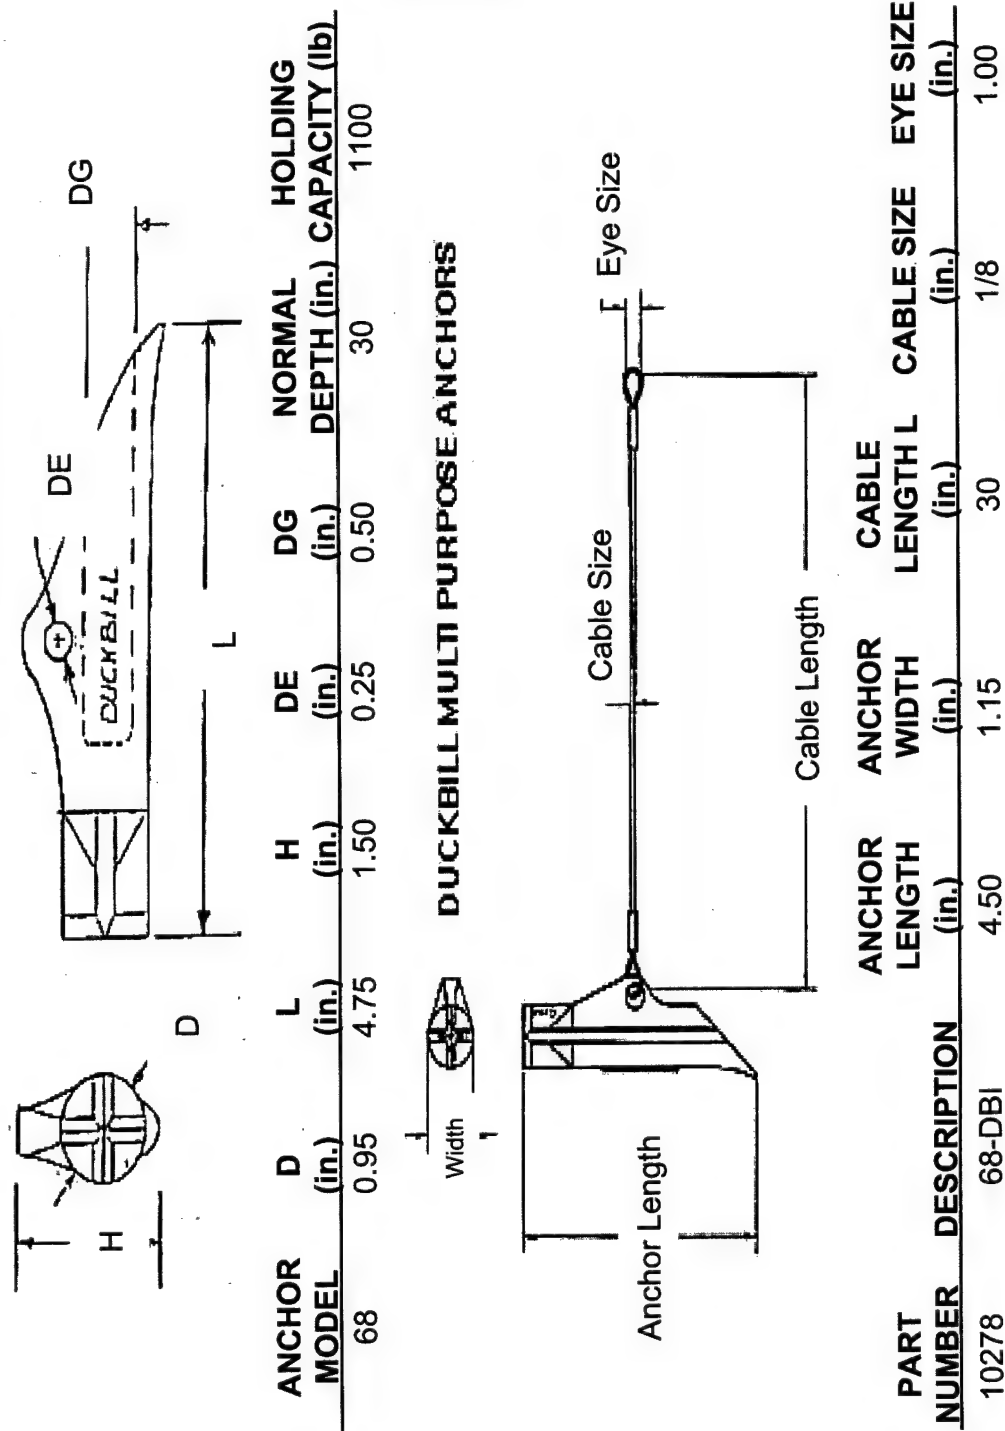
Figure 7. Duckbill anchor dimensions

Anchoring system. The MP mat item was anchored using a multi purpose Duckbill anchor system to prevent excessive movement caused by shear and centrifugal forces acting on curved sections. The anchor was driven into the ground using a hammer and a steel drive rod. The Duckbill anchor worked as a toggle bolt when rotate in undisturbed soil (Figure 6). For this investigation, the selected model was the 68-DB1. The anchor's manufacturer provided the engineering properties (www.earthanchor.com). The anchor holding power in normal soil is 1,100 lb. The wire rope breaking strength is 1,700 lb, and its length is 2.5 ft. The anchor weight is 4.5 ounces. The steel drive rod diameter is 0.5 in. The anchor's material properties are as follows: casting method - die cast, aluminum alloy - k-9, tensile yield strength - 20,700 psi, ultimate tensile strength - 26,500 psi, and elongation - 3.5 percent. Anchors were shipped in boxes of twenty-four with a total weight of 2 lb per box. Basic dimensions of the anchor and steel drive rod are shown in Figures 7 and 8, respectively. A total of 960 anchors and 2 steel drive rods were purchased for this experiment. The cost of the anchor and driven steel rod was \$4.40 and \$28.50, respectively.

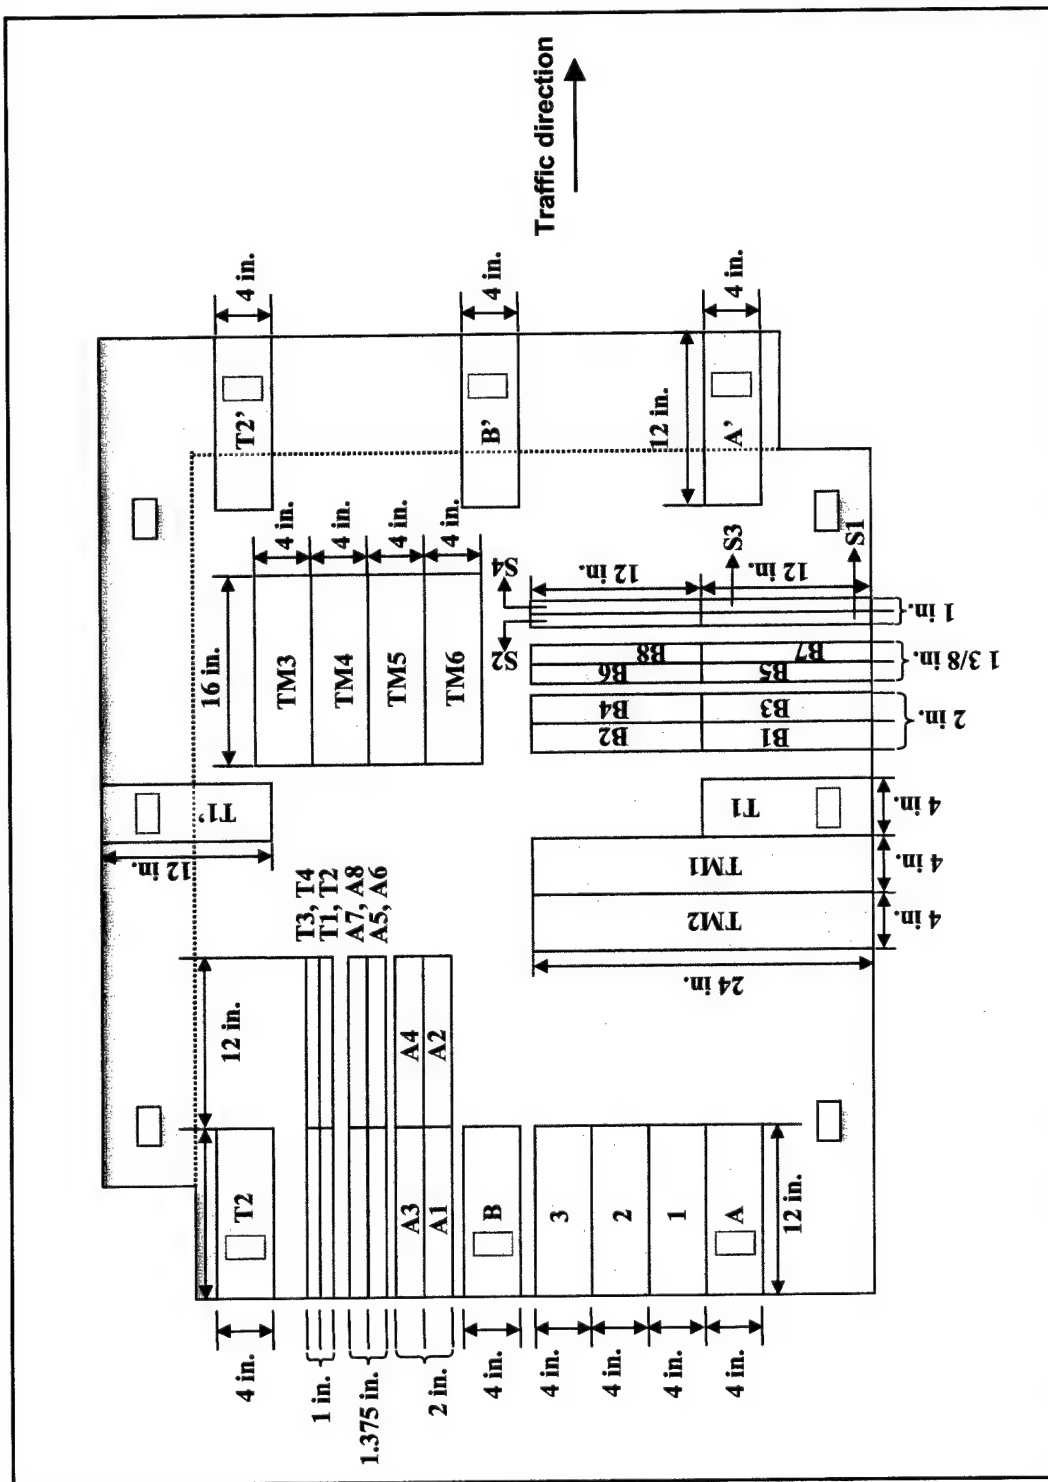
Figure 9. MP mat sample locations

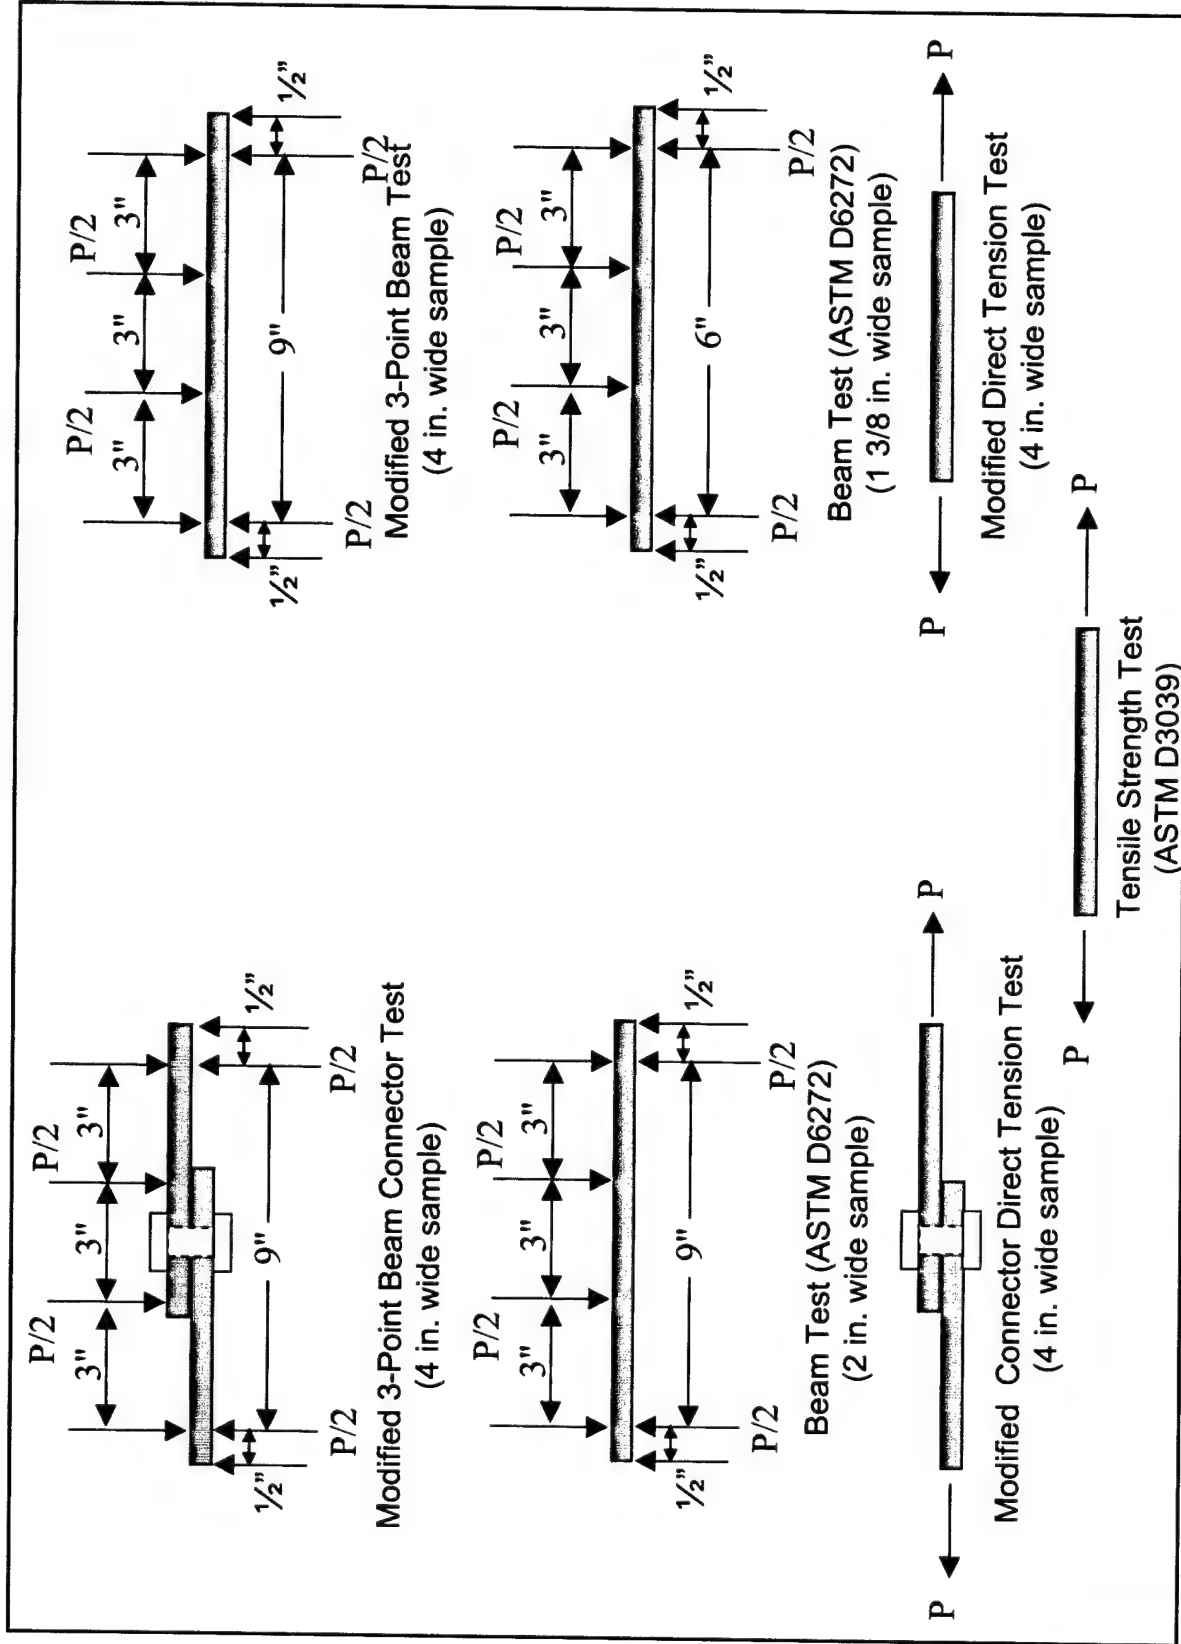
Figure 10. Test set up for the MP mat samples

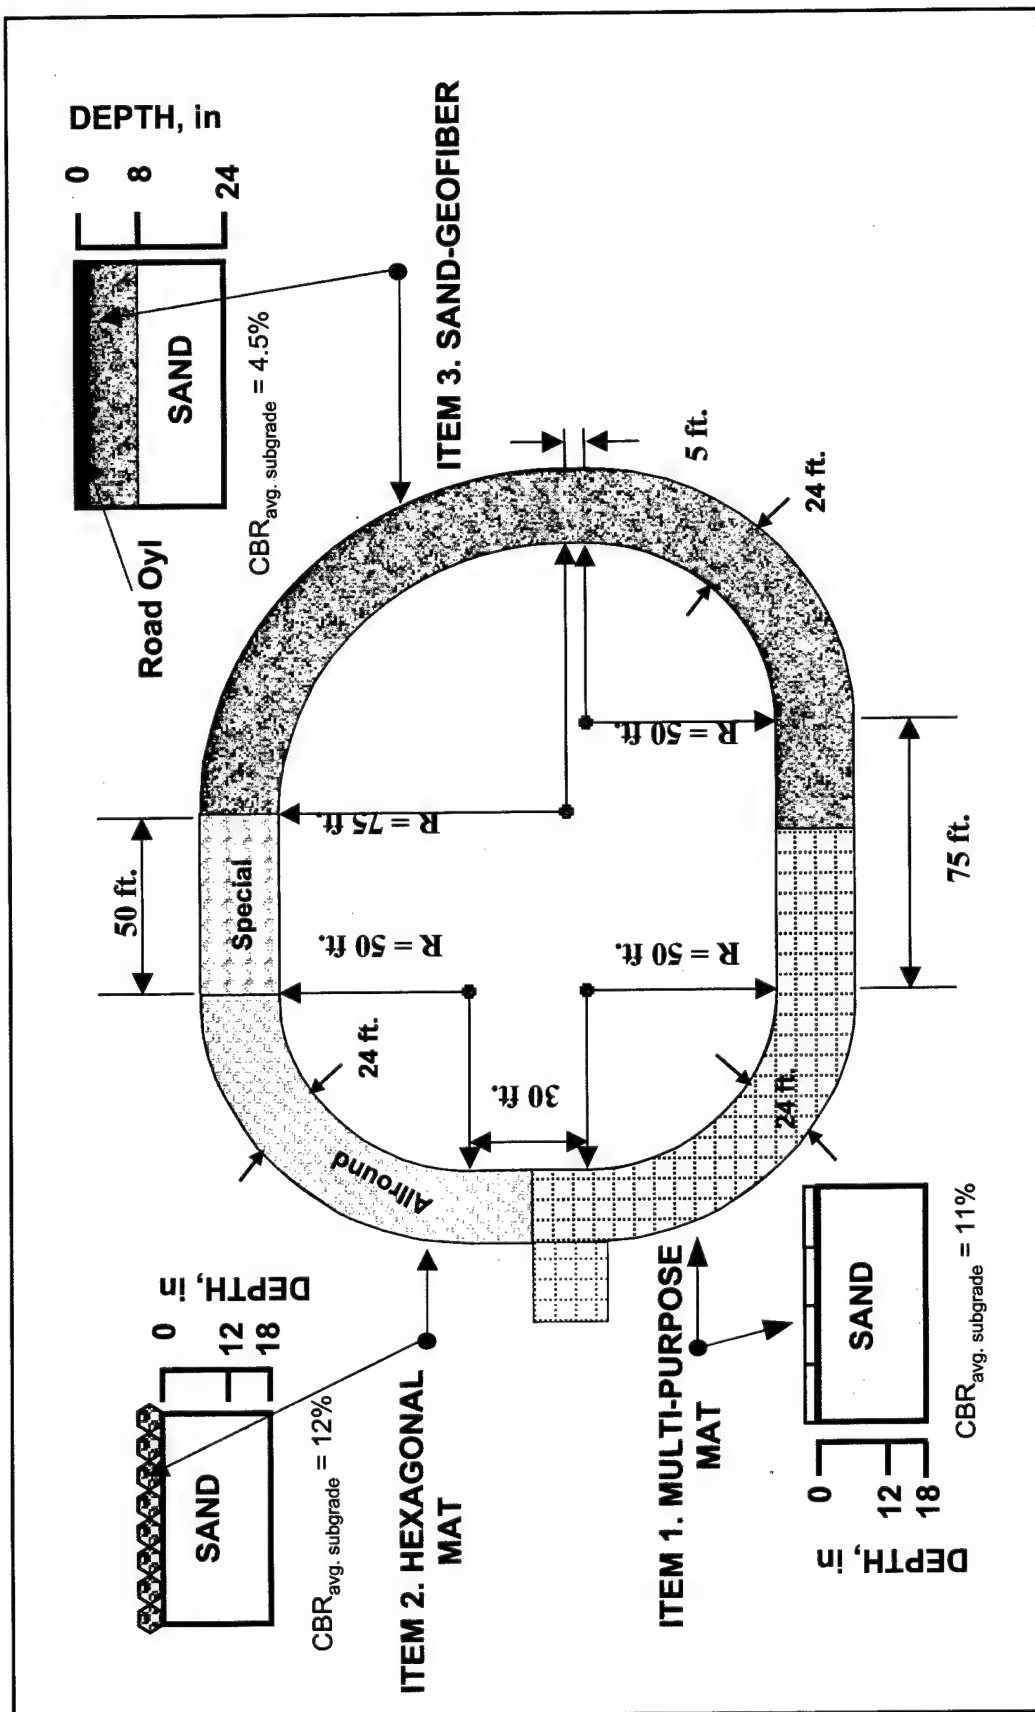
Figure 11. Full-scale field test section plan and profile view

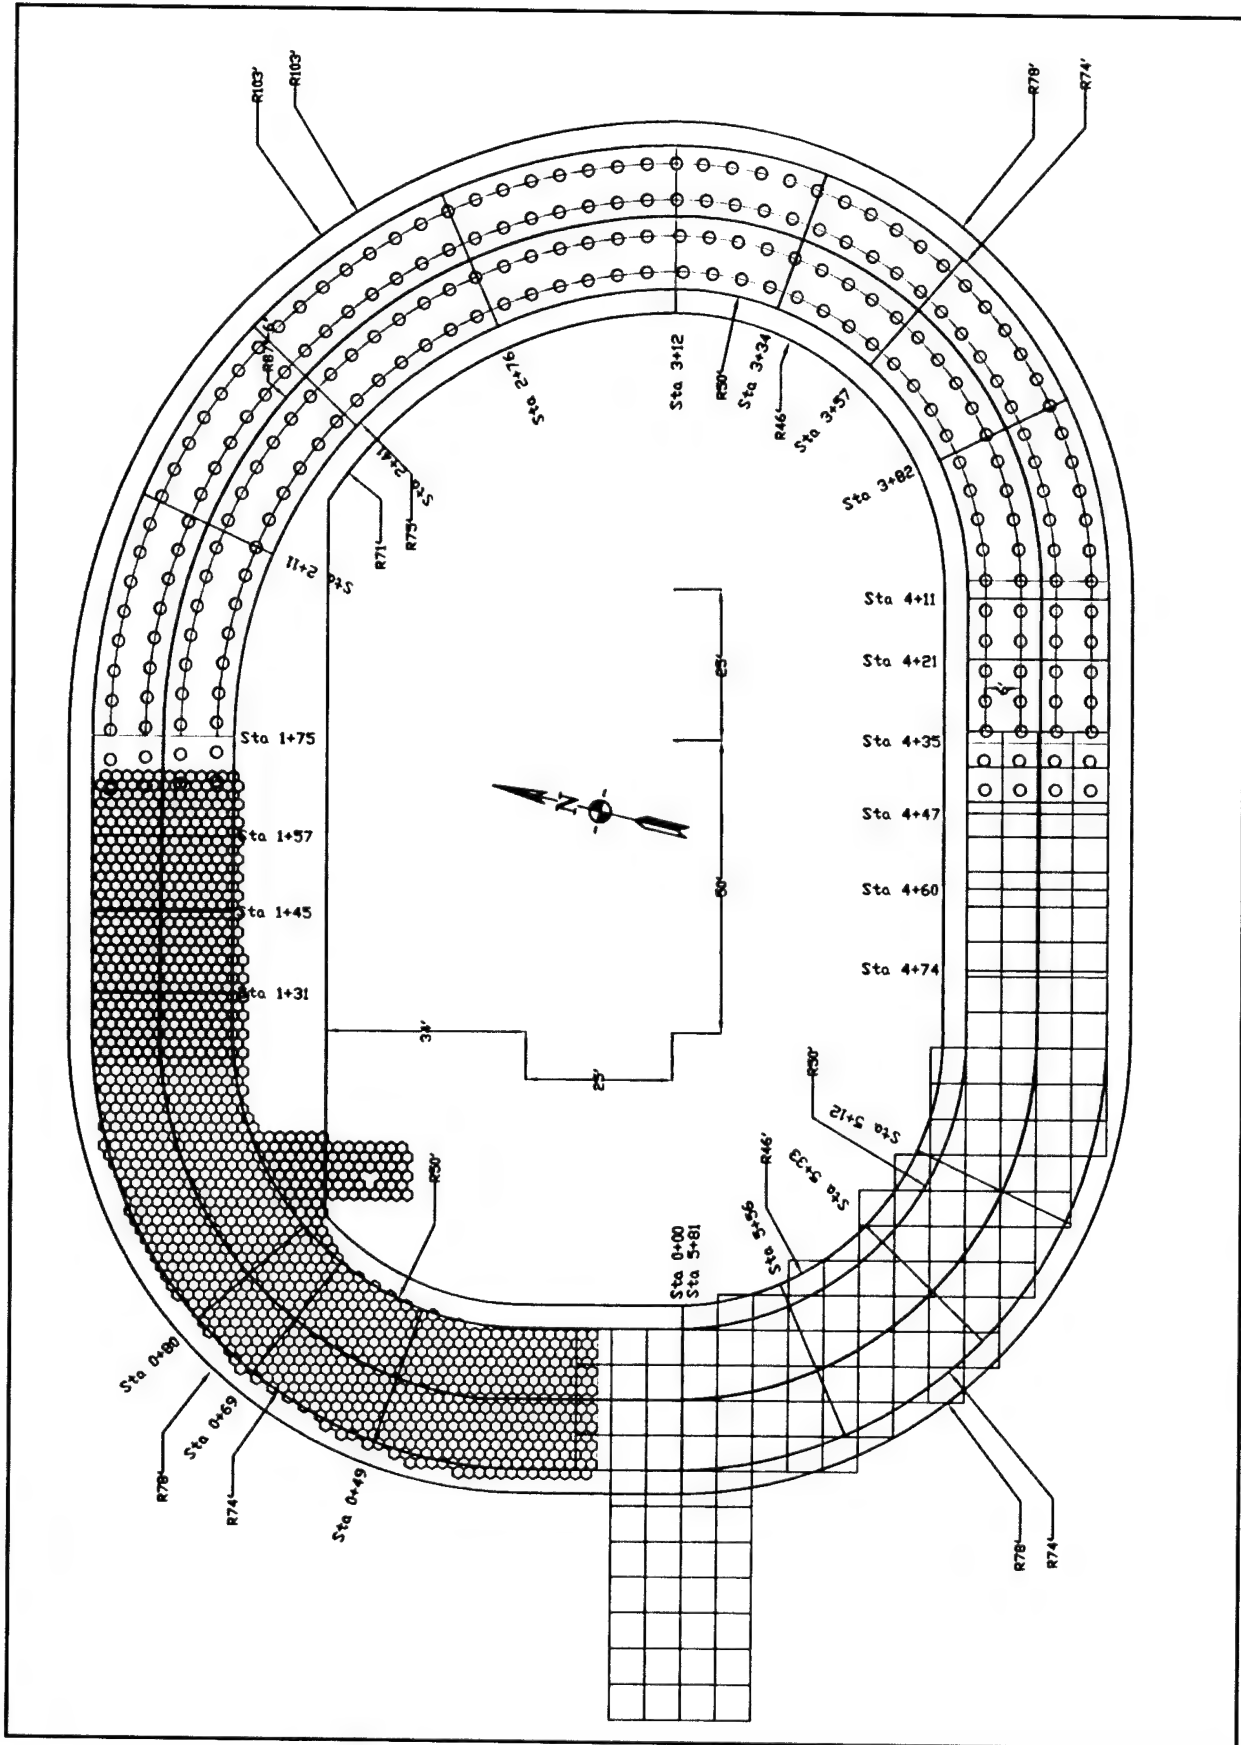
Figure 12. Plan view showing mat placement pattern

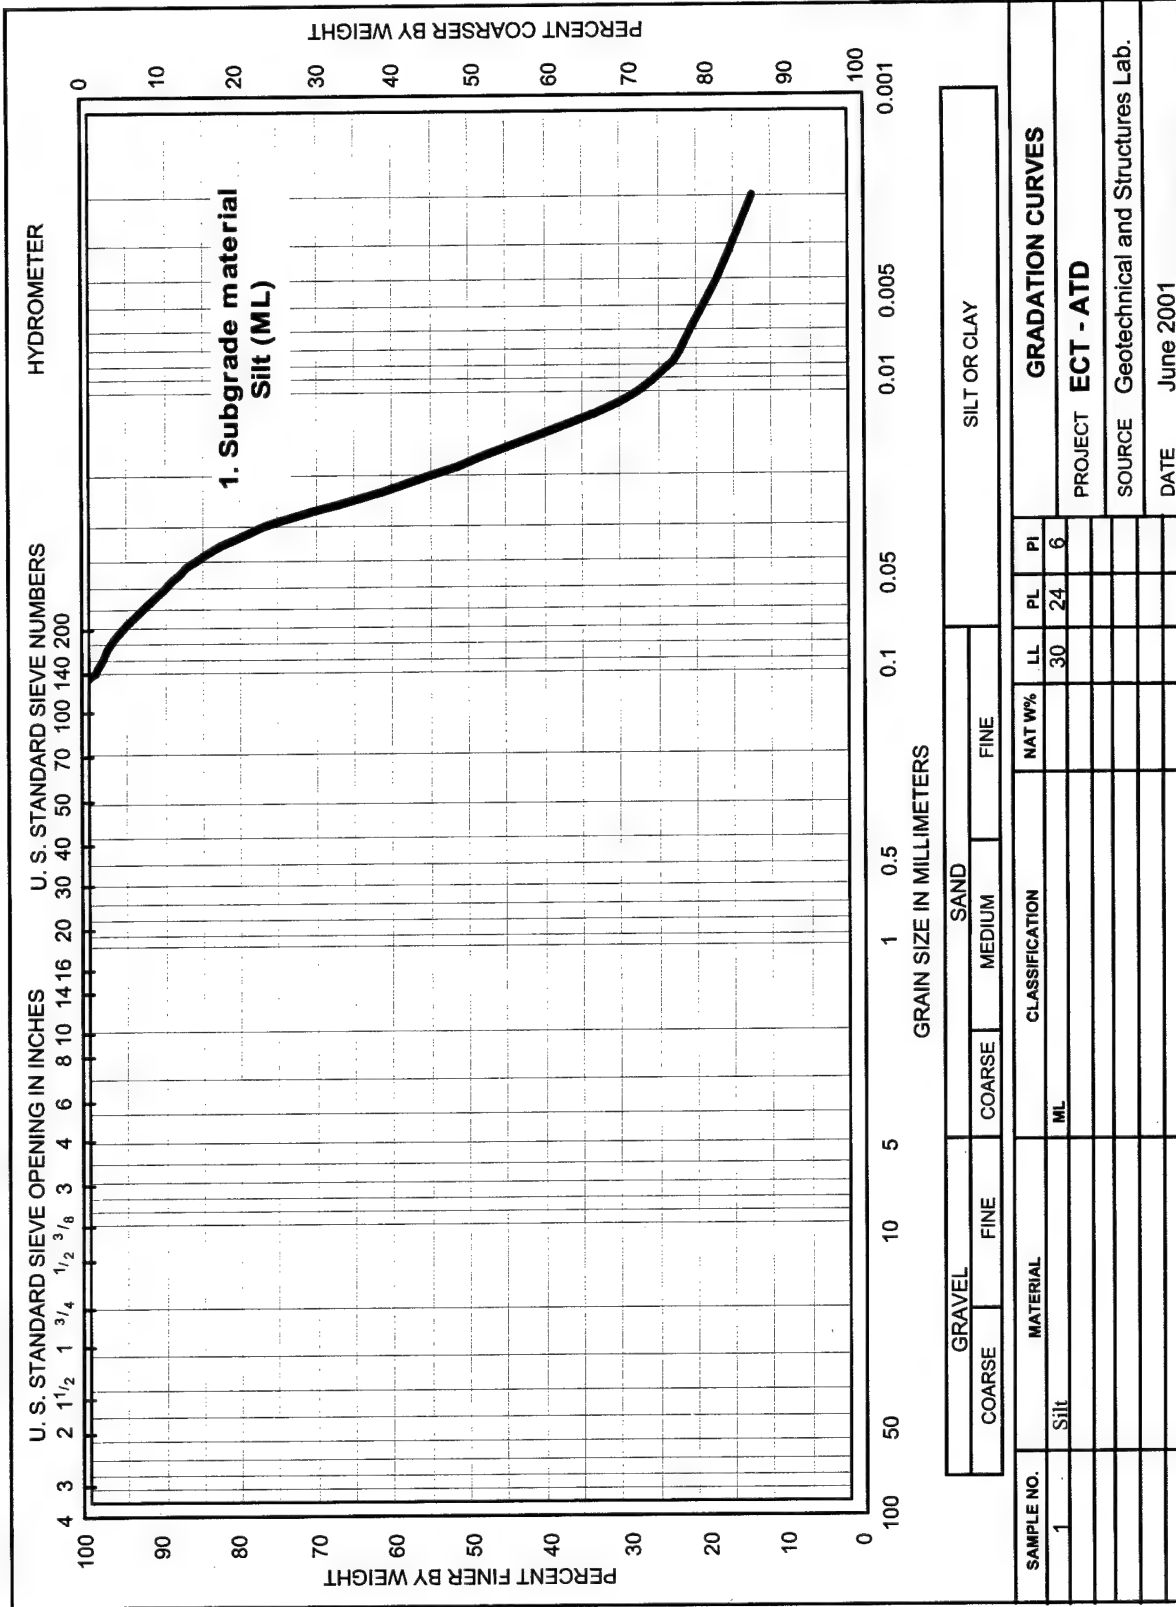
Figure 13. Classification data and gradation curve for dredge material

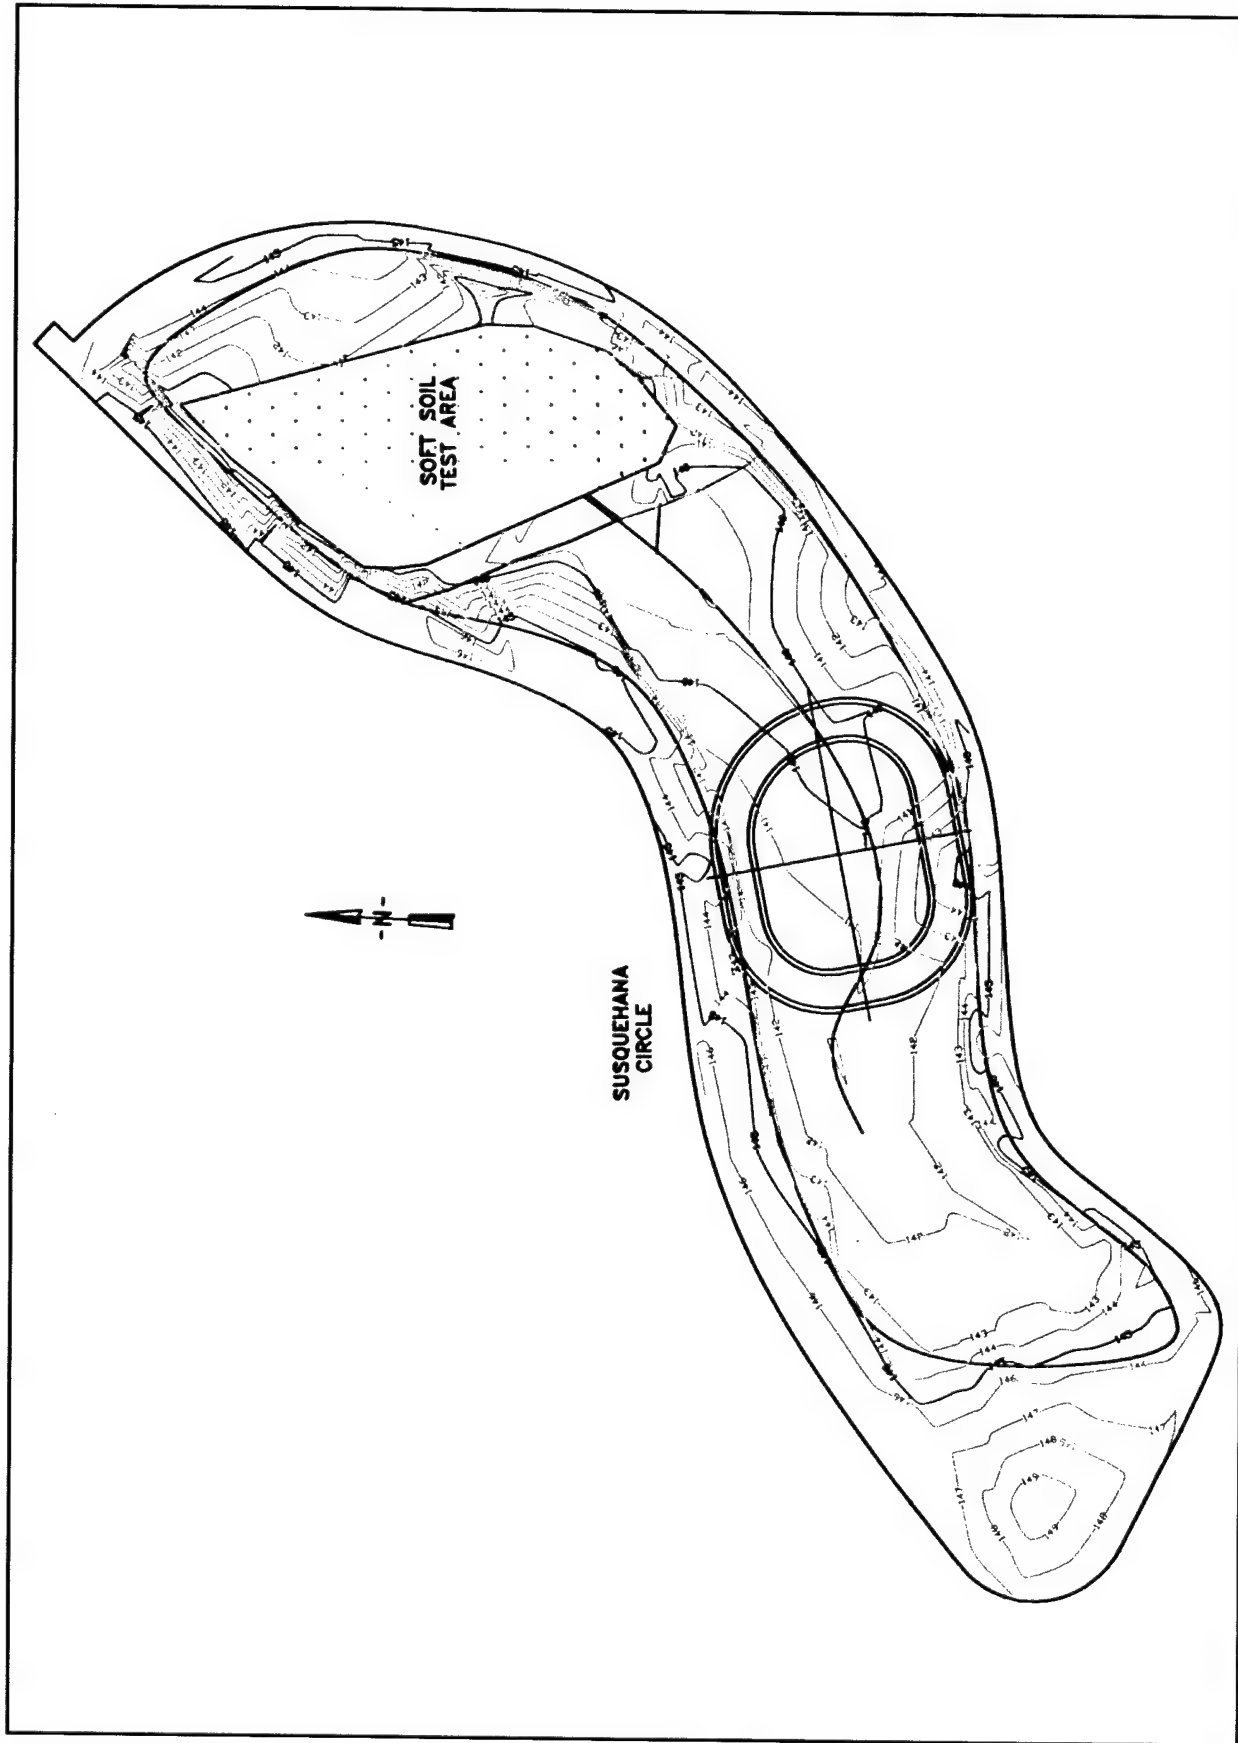
Figure 14. Elevations and plan view of the field site

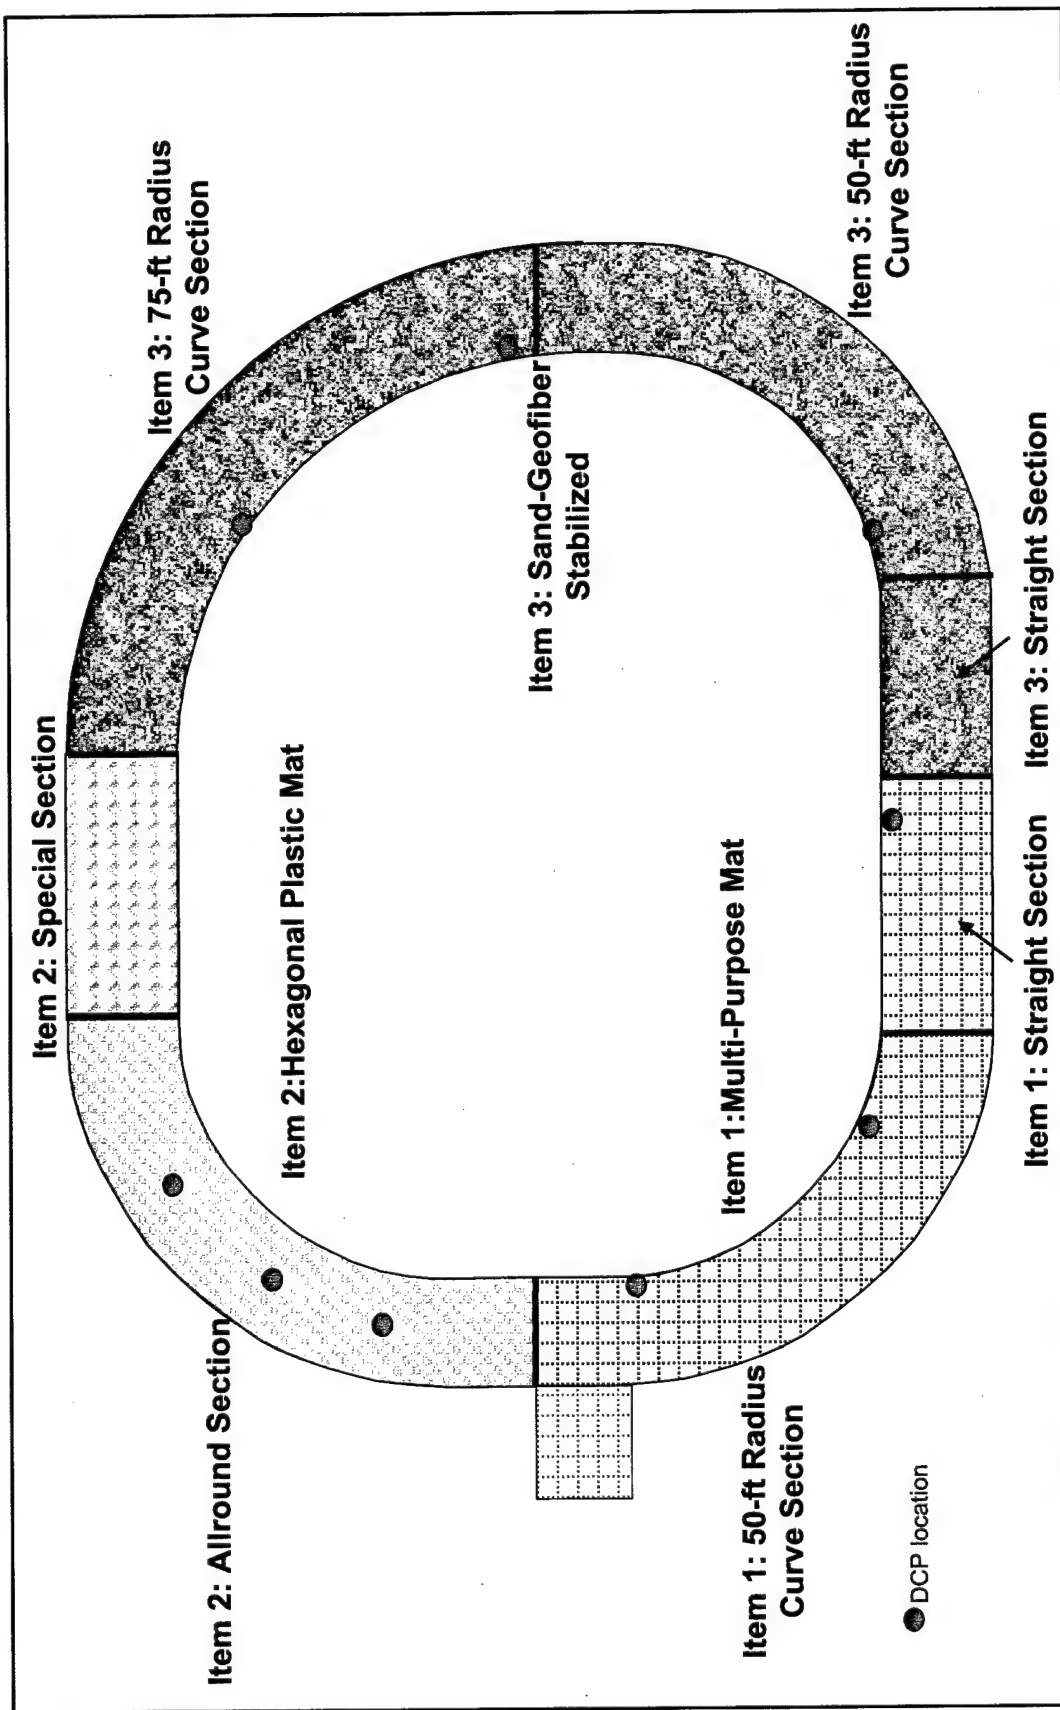
Figure 15. Item's sections layout
